TSD File Inventory Index

Facility Name <u>CMC Kalamazoo Inc. (One Teller Site)</u>			
Facility Identification Number <u>MLD 005 319 009</u>			
A.1 General Correspondence		B.2 Permit Docket (B.1.2)	
A.2 Part A / Interim Status		1 Correspondence	
1 Correspondence	<u>Y</u>	2 All Other Permitting Documents (Not Part of the ARA)	
2 Notification and Acknowledgment	<u>Y</u>	C.1 Compliance - (Inspection Reports)	<u>Y</u>
3 Part A Application and Amendments	<u>Y</u>	C.2 Compliance/Enforcement	<u>Y</u>
4 Financial Insurance (Sudden, Non Sudden)	<u>Y</u>	1 Land Disposal Restriction Notifications	
5 Change Under Interim Status Requests		2 Import/Export Notifications	
6 Annual and Biennial Reports		C.3 FOIA Exemptions - Non-Releasable Documents	
A.3 Groundwater Monitoring		D.1 Corrective Action/Facility Assessment	<u>Y</u>
1 Correspondence		1 RFA Correspondence	
2 Reports		2 Background Reports, Supporting Docs and Studies	
A.4 Closure/Post Closure		3 State Prelim. Investigation Memos

**PHOTOGRAPHIC LOG
CHECKER MOTORS CORPORATION
KALAMAZOO, MICHIGAN**

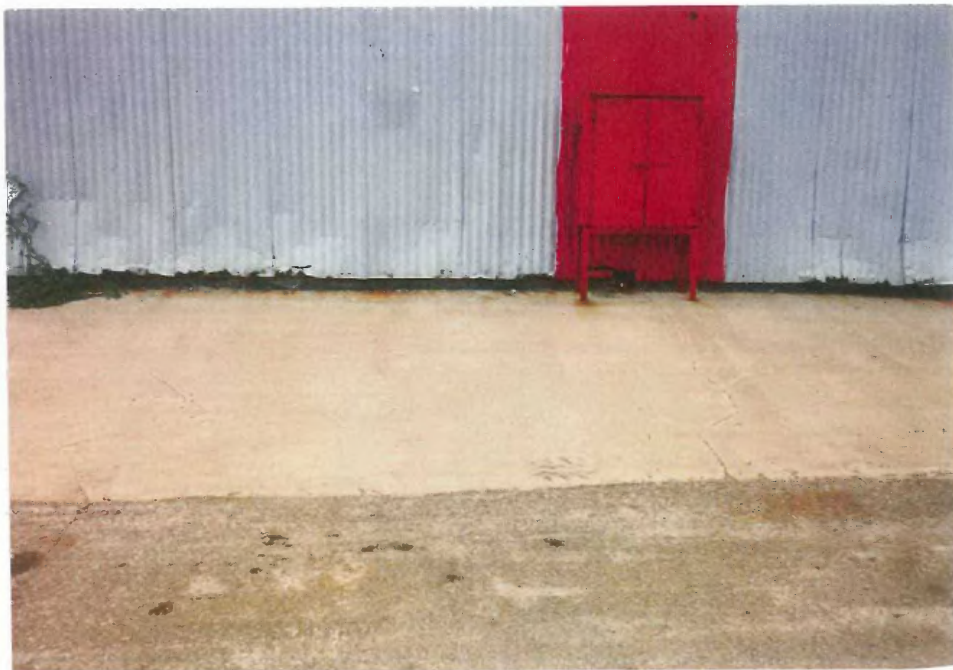
Location: AOC No. 3
 Date: October 7, 1991

Photo No.: 1
 Orientation: South
 Description: UST Area No. 1. Three gasoline USTs and two lacquer thinner USTs were removed from this location in 1982.

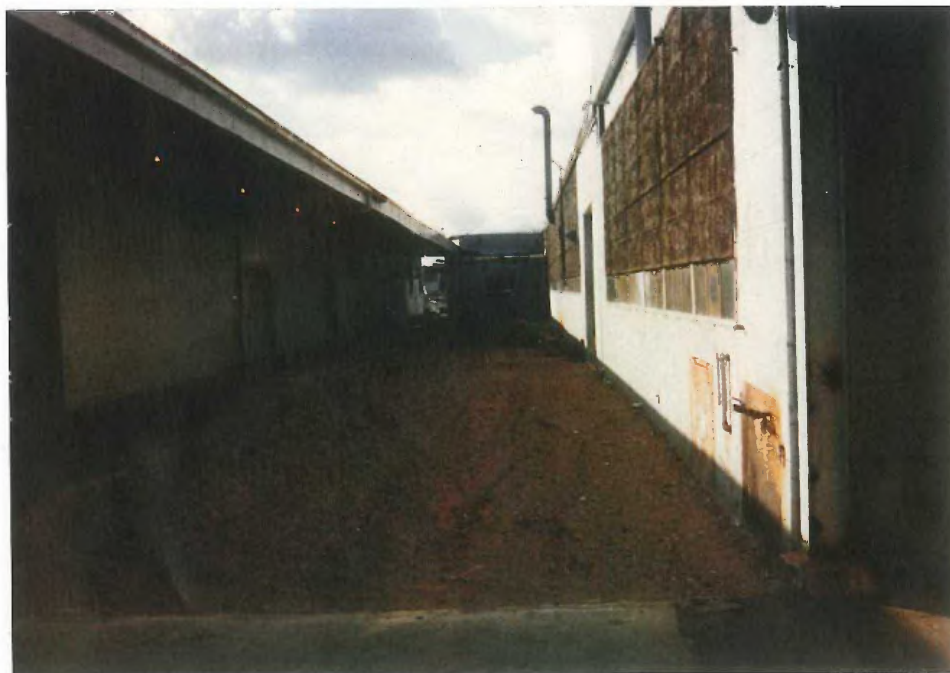
Location: AOC No. 4
 Date: October 7, 1991

Photo No.: 2
 Orientation: North
 Description: UST Area No. 2. One 1,000-gallon wax UST and one 5,000-gallon mineral spirits UST were removed from this area in 1990.

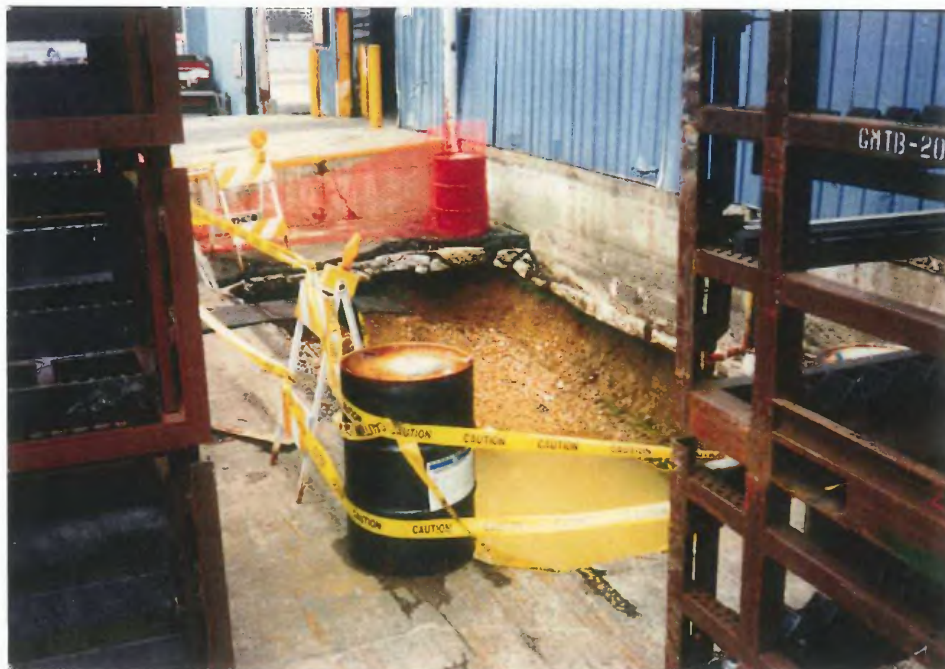
Location: AOC No. 5
 Date: October 7, 1991

Photo No.: 3
 Orientation: Southwest
 Description: UST Area No. 3. One 6,000-gallon leaded gasoline UST was removed from this location in December 1990.

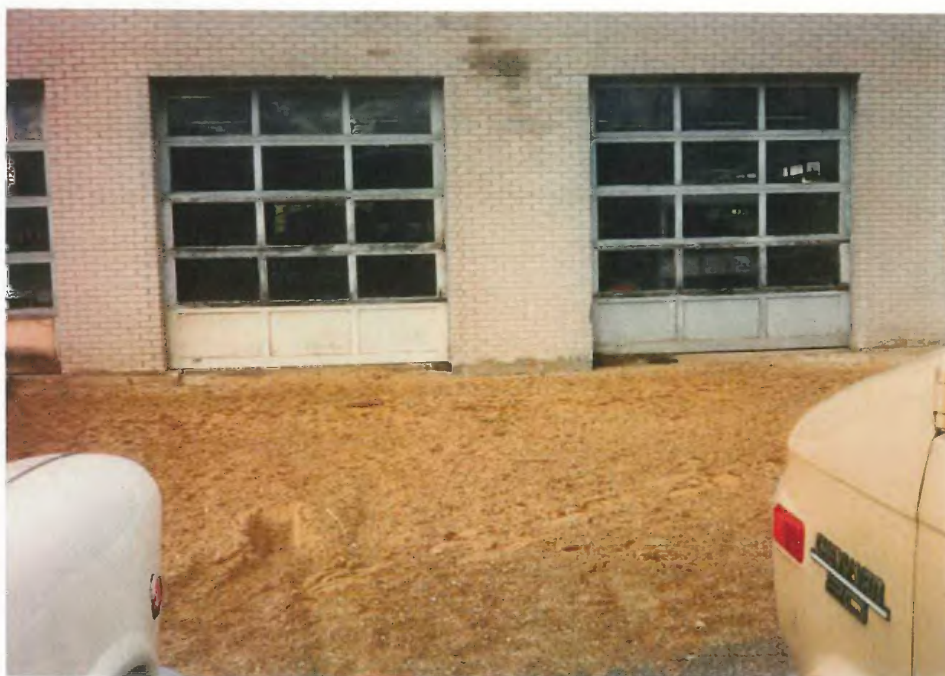
Location: SWMU No. 5
 Date: October 7, 1991

Photo No.: 4
 Orientation: West
 Description: One 250-gallon waste oil UST was removed from this area in 1989. The excavation area has been backfilled with sand and gravel.

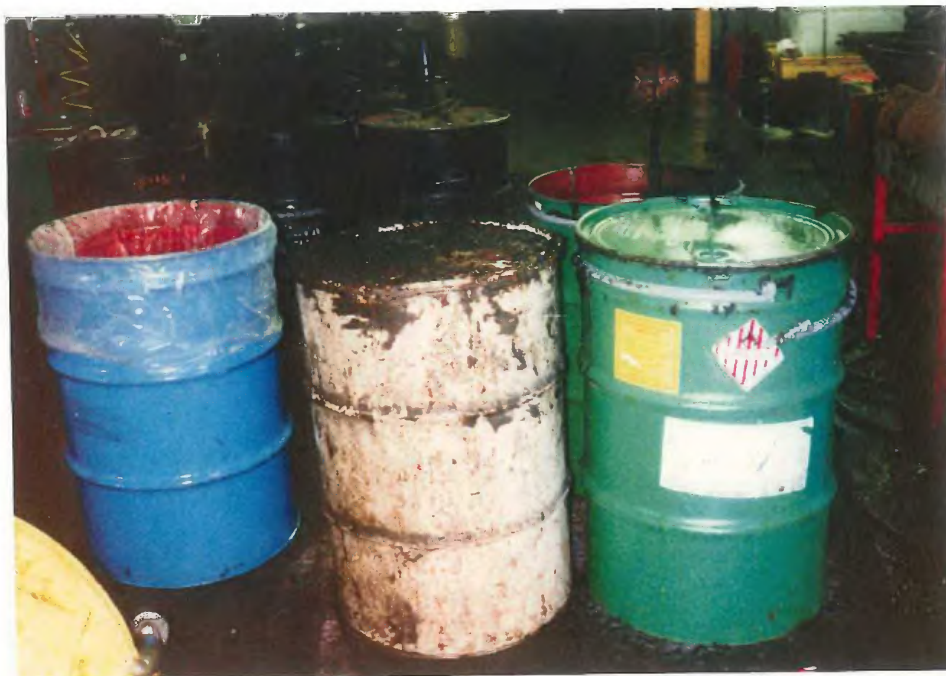
Photo No.: 5
Orientation: East

Description: Drum containing dirty liner is open and on the left of the photo. A satellite accumulation drum filled with drum bottoms cleaned from dirty liners is on the right.

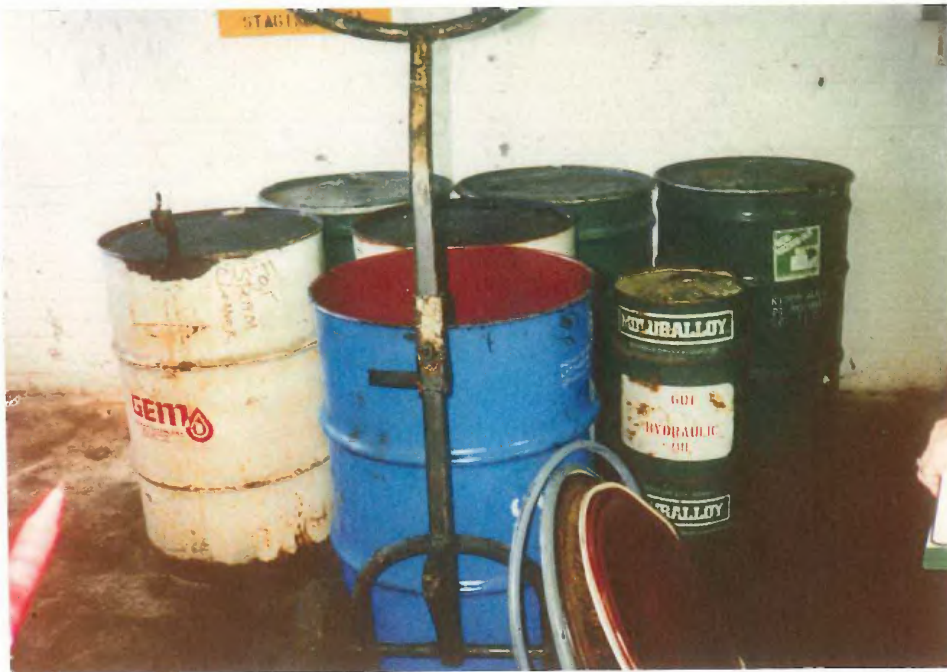
Photo No.: 7
 Orientation: North
 Location: SWMU Nos. 1 and 6
 Date: October 7, 1991
 Description: Hazardous waste drum storage area (SWMU No. 1); also used as one of three waste oil drum collection areas (SWMU No. 6). Blue drum in foreground is used to collect dirty drum liners (See Photo No. 6). Approximately once per week, dirty liners collected here are manually cleaned. Drum bottoms (D001) are placed in satellite accumulation drum (See Photo No. 5). Cleaned plastic liners, no longer ignitable, are disposed of with municipal trash.

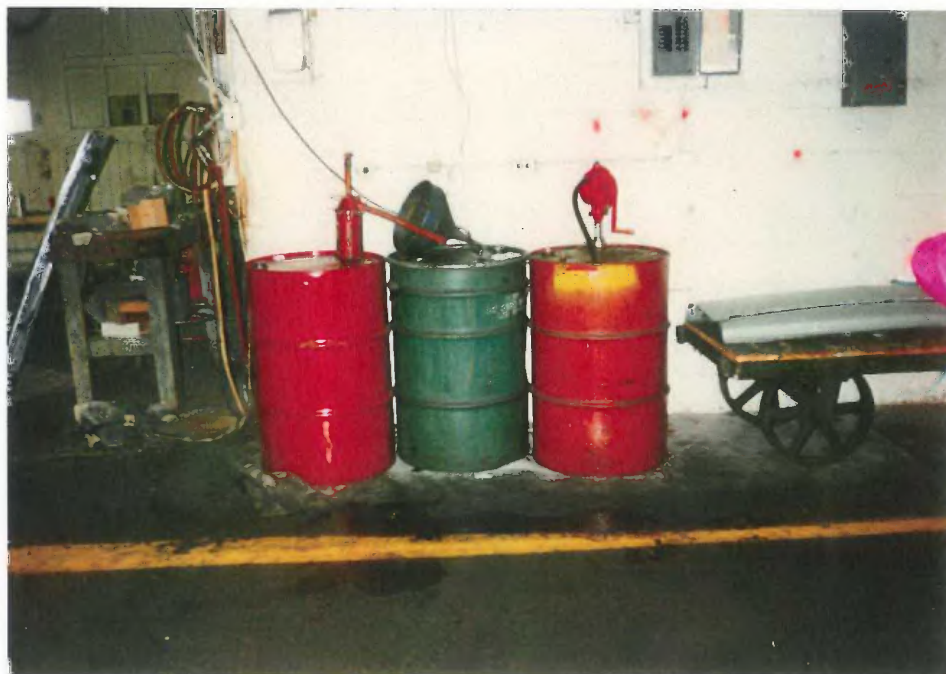
Photo No.: 8
 Orientation: North
 Location: SWMU No. 6
 Date: October 7, 1991
 Description: One of three waste oil drum collection areas. This one is located inside Plant No. 1. Drum in center of photo contains waste oil.

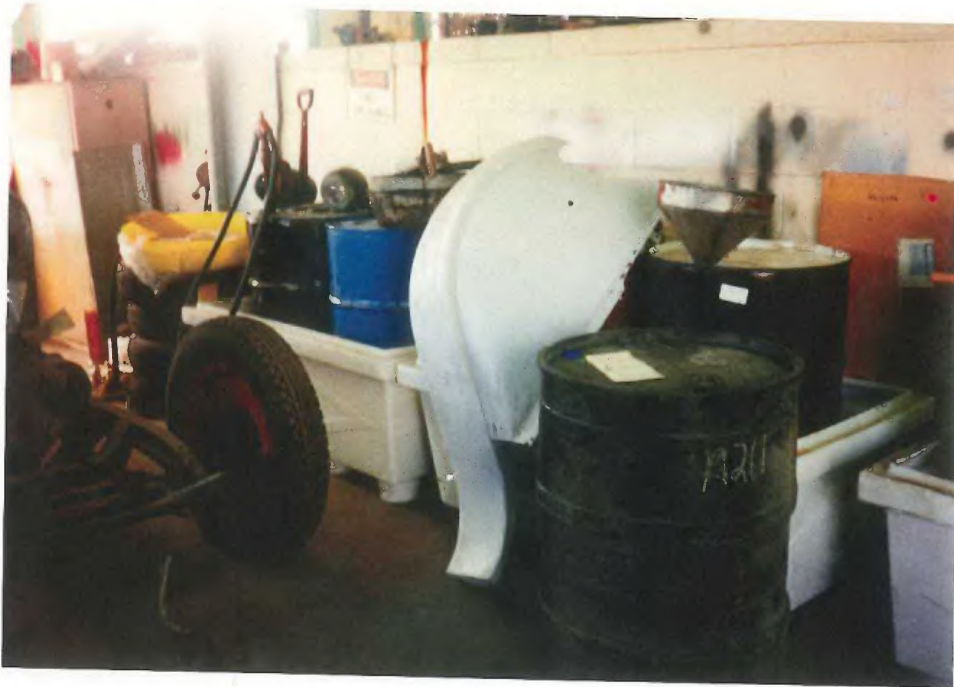
Photo: 9
 Location: SWMU No. 6
 Orientation: South
 Date: October 7, 1991
 Description: One of three waste oil drum collection areas. This one is located in the Service Garage. Waste oil drums are staged inside fiberglass tubs.

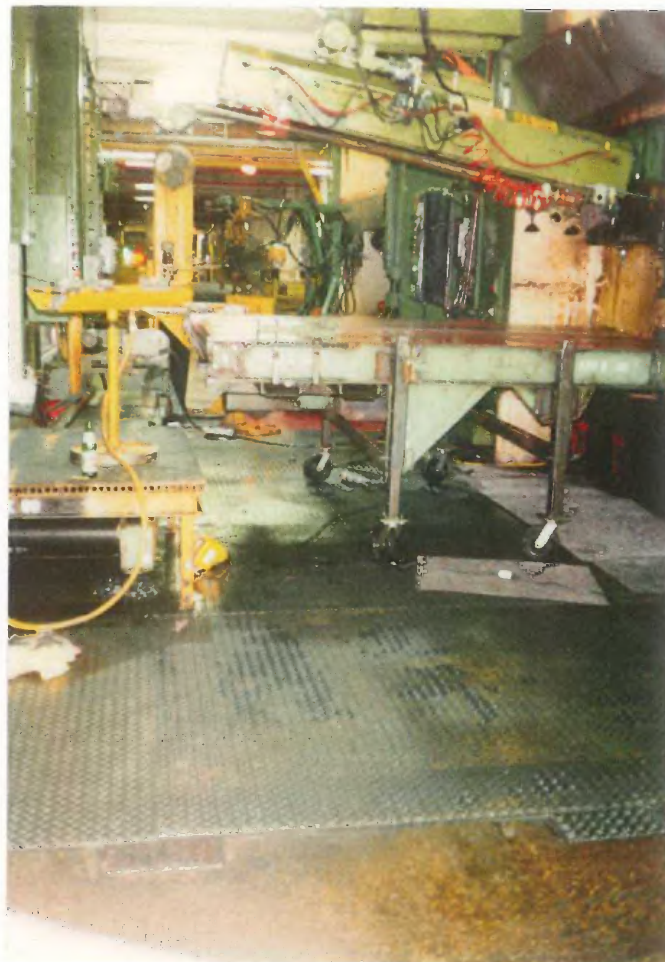
Photo No.: 10
 Location: SWMU No. 2
 Orientation: East
 Date: October 7, 1991
 Description: One of approximately 40 pressing/stamping lines. The oily wastewater collection pits are located under each pressing/stamping line.

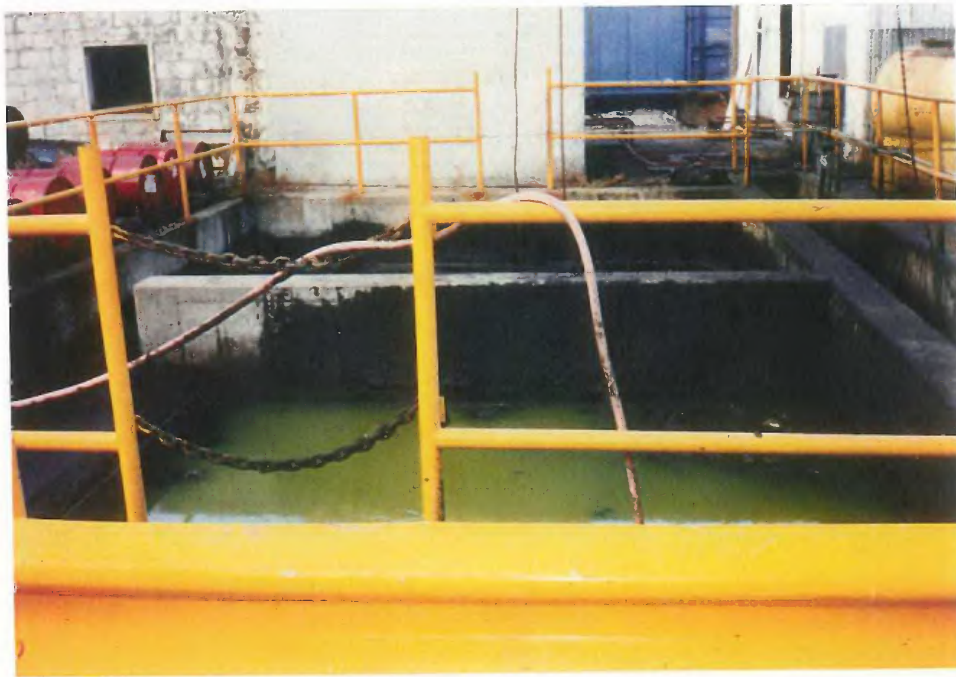
Location: SWMU No. 3
 Date: October 7, 1991

Photo No.: 11
 Orientation: West
 Description: Sludge pit containing oily wastewater from SWMU No. 2. Concrete walls of pit are stained from oil. The 14-foot wall in the center of the pit gives the appearance of two pits.

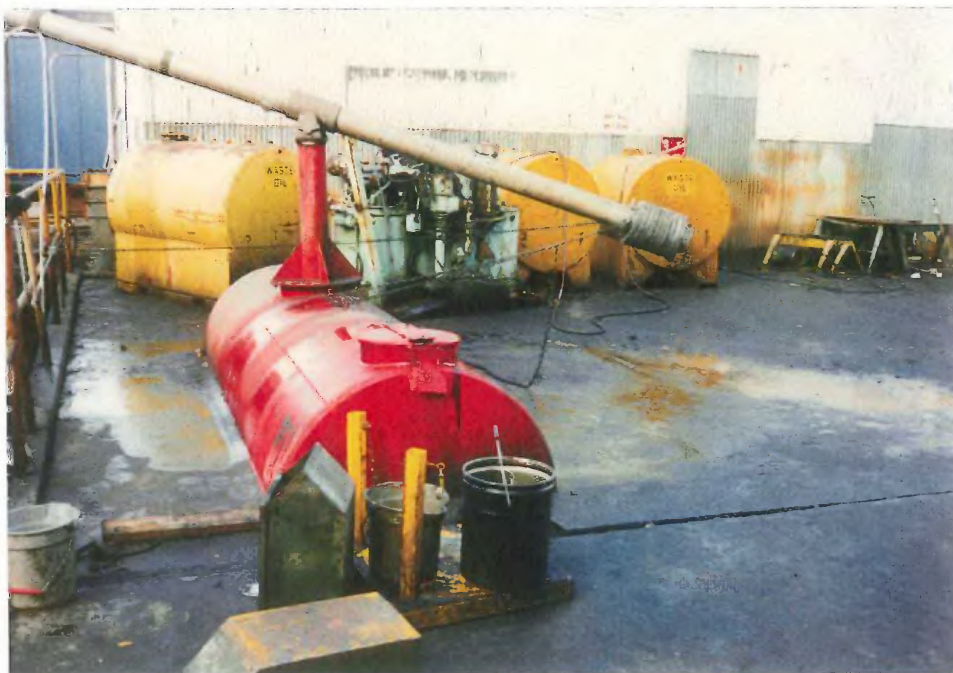
Location: SWMU Nos. 8 and 10
 Date: October 7, 1991

Photo No.: 12
 Orientation: West
 Description: 1,000-gallon waste oil UST (SWMU No. 10) used to store oil skimmed from sludge pit (SWMU No. 3) is in foreground. In the rear of the photo are three of four 500-gallon portable waste oil ASTs (SWMU No. 8). Steel plates covering the ground in this area contain puddles of water with oily sheens and are stained in areas.

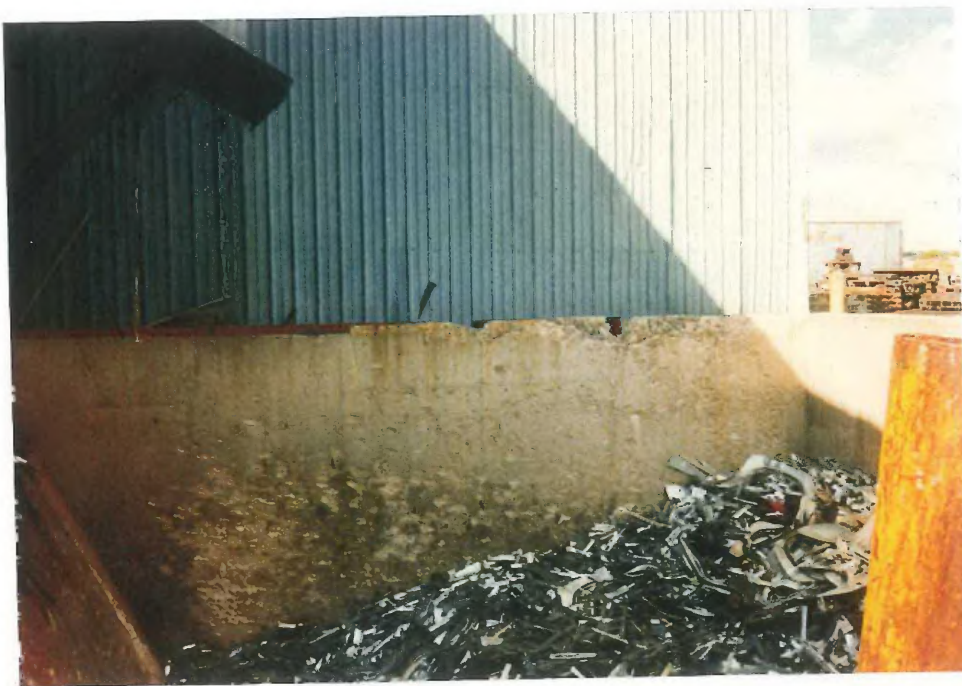
Location: SWMU No. 4
 Date: October 7, 1991

Photo No.: 13
 Orientation: West
 Description: Scrap metal accumulation pit located outside Plant No. 2.

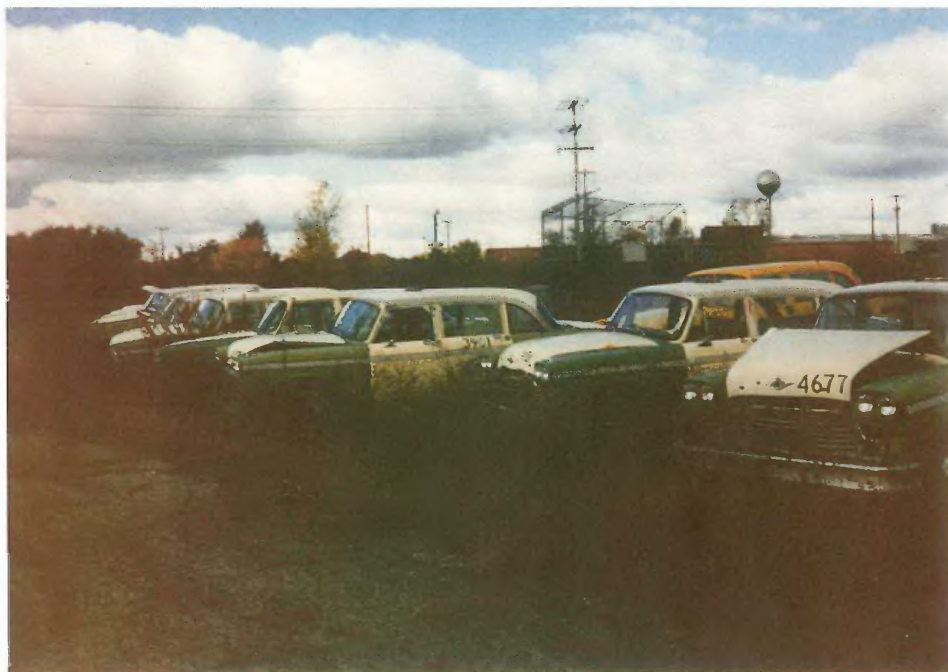
Location: AOC No. 6
 Date: October 7, 1991

Photo No.: 14
 Orientation: West
 Description: Old taxis in taxi storage yard at north end of the facility property. Area underneath and behind the taxis is unimproved and not paved.

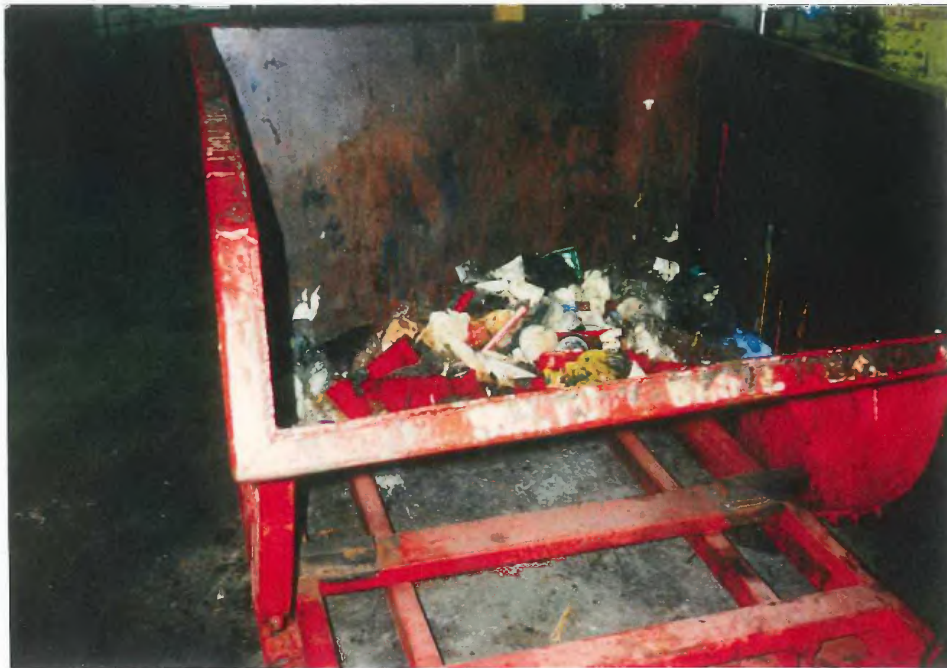
Location: SWMU No. 9

Photo No.: 15
 Orientation: South
 Description: Oily solid material in one cubic-yard hopper located in Plant No. 2, near the metal stamping/pressing lines.

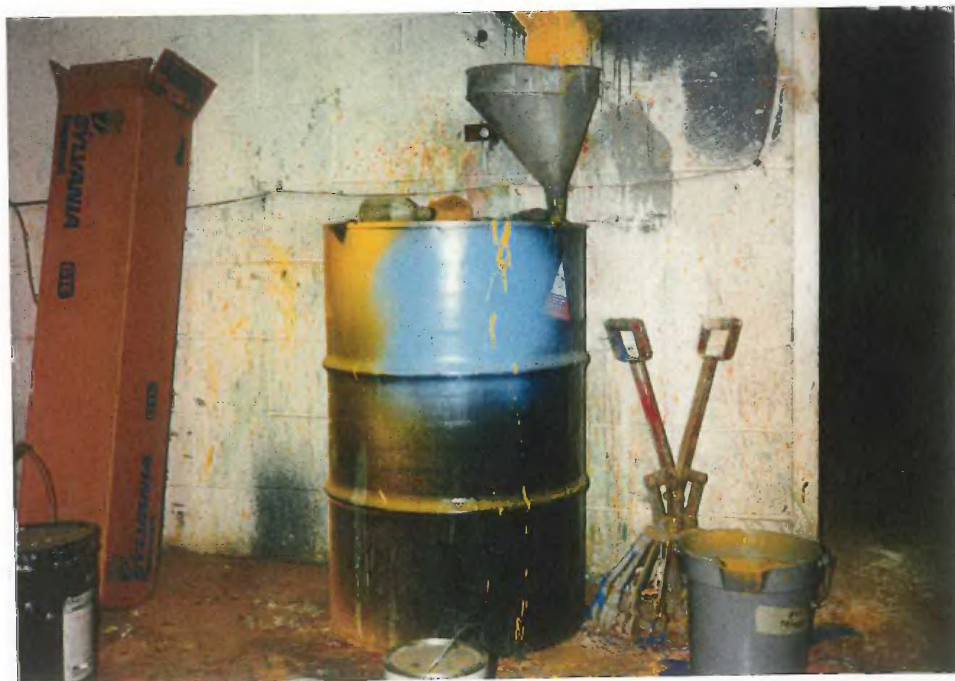
Location: SWMU No. 7

Photo No.: 16
 Orientation: South
 Description: Waste paint satellite accumulation drums (D001) located on second floor of Plant No. 2. The drum has an open bung and the funnel does not have a cover.

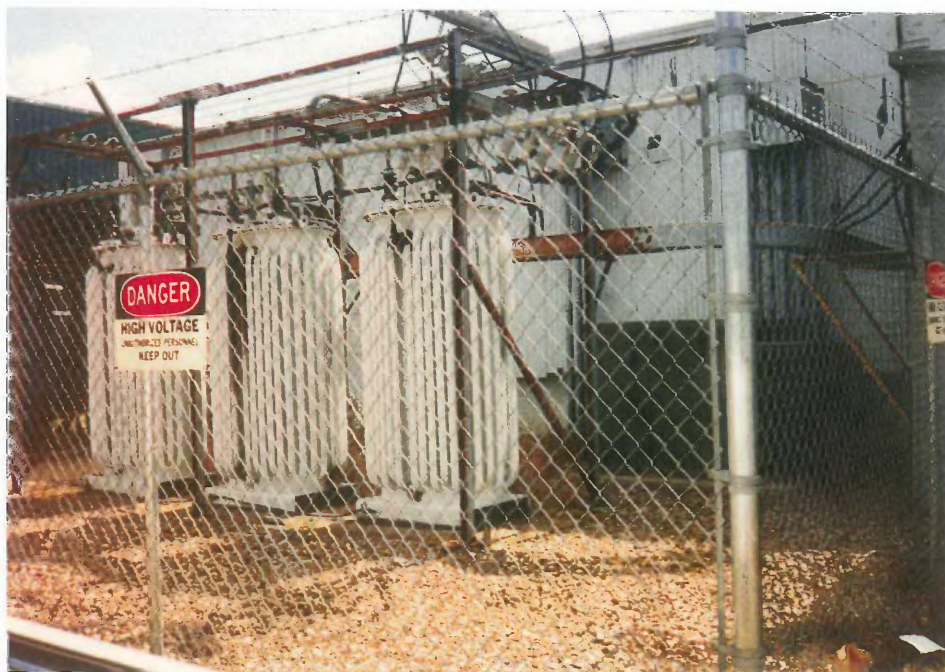
Photo No.: 17

Description: PCB-Containing Transformer Area. PCB-containing transformer that leaked in 1986 was removed from this location, along with contaminated soil.

transformer leak - 200 yds soil &
 concrete (PCB) to 'clean' dirt 1987
 MNR supervised.
